National Transportation Safety Board

Marine Accident Brief

Allision of Cruise Ship *Celebrity Infinity* with Dock

Accident no.	DCA16FM042
Vessel name	<i>Celebrity Infinity</i>
Accident type	Allision
Location	Berth 3, Ketchikan, Alaska, 55° 20.5' N, 131° 39.04' W
Date	June 3, 2016
Time	1356 Alaska daylight time (coordinated universal time – 8 hours)
Injuries	None
Property damage	\$1.15 million est.
Environmental damage	None
Weather	Rain, visibility 7 miles, south-southeast winds at 38–45 knots, choppy seas, air temperature 55°F, water temperature 52°F
Waterway information	Berth 3 is located in the east channel of the Tongass Narrows on the southwest side of Revillagigedo Island. The narrows is about 3.3 miles long and 0.44 mile wide and runs northwest to southeast.

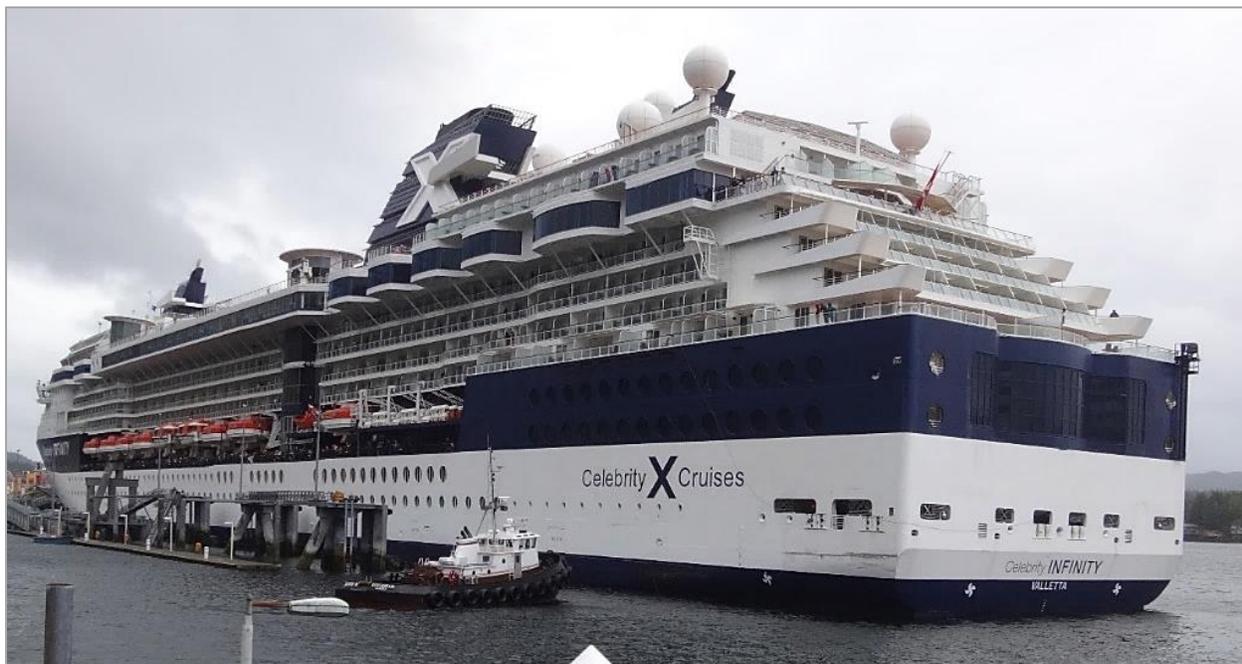
About 1400 on June 3, 2016, the Malta-flag cruise ship *Celebrity Infinity* allided with berth 3 in Ketchikan, Alaska. No one was injured and no pollution occurred. The vessel sustained a 9-inch-diameter hole on the forward port side, about 12 feet above the waterline. The berth suffered extensive damage to the catwalks and pilings. The cost of repairs was about \$1.15 million.

Postaccident photo of *Celebrity Infinity* docked at damaged berth 3, Ketchikan, Alaska. (Photo by Coast Guard)

The pilot told investigators that dropping the starboard anchor slowed the motion of the bow toward the pier. The master said that he then ordered chain to be paid out so the vessel could move forward and toward the dock, but the VDR recording captured the master's order as "hold the anchor." According to the pilot, the thrusters and anchor were able to control the bow but "whatever maneuvers they made with the pods weren't sufficient to hold the ship and it made a hard landing on the dolphins back there." At 1355, with the after part of the vessel pivoting toward berth 3, the VDR recorded someone shouting, "the stern, the stern!" and, at 1356, the vessel allided with the berth. The force of the allision opened a 9-inch-diameter hole in the vessel's port side between frames 231 and 233, about 12 feet above the waterline. It also caused the deflection of vessel structural members. The berth suffered extensive damage to its catwalks and structural members. Damage to the berth and vessel was estimated at \$1,153,738.

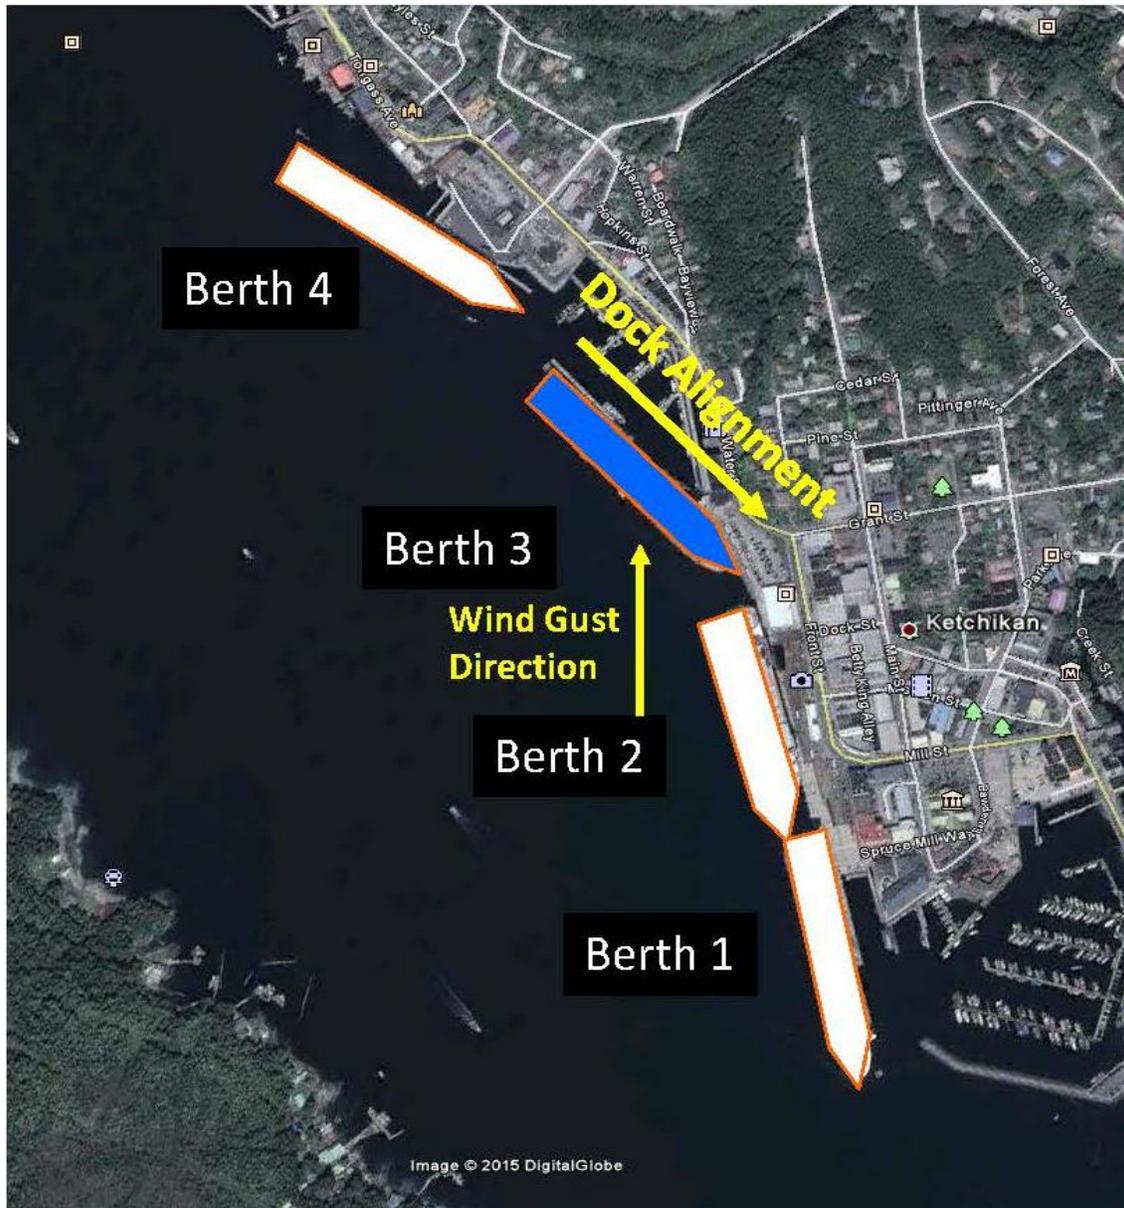
Ketchikan harbor with overlaid approximate positions of cruise ships at cruise vessel berths. The blue ship shows the approximate position of *Celebrity Infinity* at berth 3. (Background by DigitalGlobe)

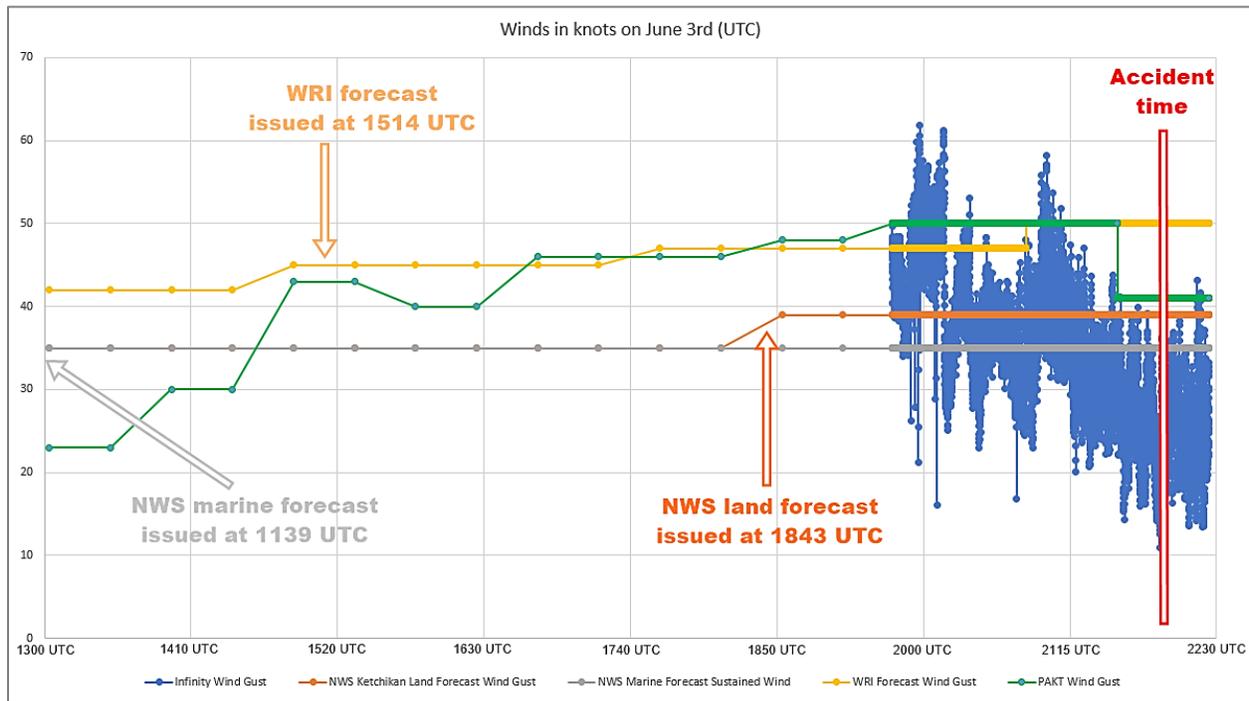
Graphic of the wind conditions leading up to the accident.

Investigators viewed the CCTV recordings from cameras located at the port bridge wing conning station, a deck camera looking forward from the stern, and a deck camera looking aft from the bow. Investigators also listened to the VDR recording of the vessel approaching the berth. At 1346, the wind gusted to 40 knots and, at 1349, control of the vessel's pods and thrusters was shifted to the port bridge wing with the master, pilot, and staff captain manning the port conning station seconds later.⁶ The port bridge wing camera showed all three men looking toward the port side of the vessel and forward as the vessel neared the dock. Between 1352 and 1353, the staff captain looked toward the stern three times but did not appear to say anything on the CCTV footage, nor did the VDR record him saying anything at that time.

⁶ The *Celebrity Infinity* VDR recorded a 40-knot wind gust. At the Ketchikan airport, an anemometer recorded a rooftop wind speed (a measurement taken from a height close to the same height as the *Celebrity Infinity*'s anemometer) of 50 knots shortly after the *Celebrity Infinity* docked, and it is likely that the vessel also experienced wind gusts of 50 knots at the time of the docking.

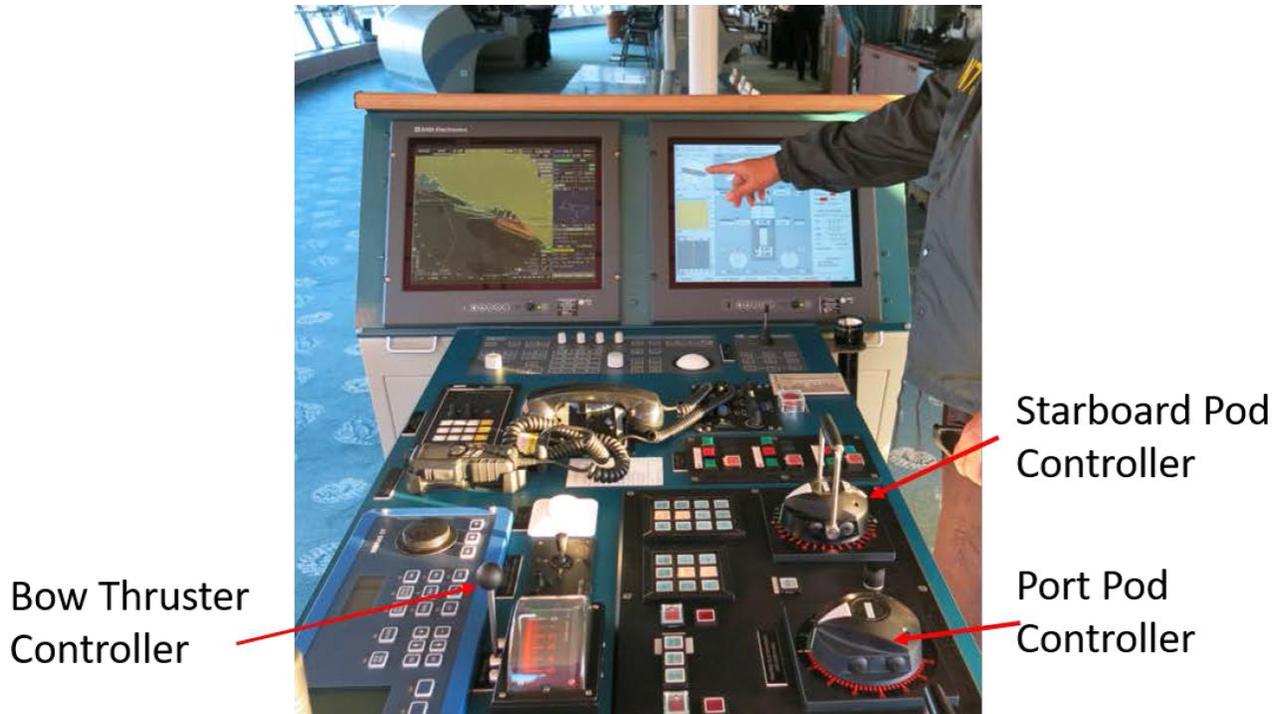
Celebrity Infinity's port bridge wing conning console (the handle to the port pod controller is missing in this photo).
